INDOOR AIR QUALITY ASSESSMENT

**Berkley Town Offices
1 North Main Street
Berkley, Massachusetts**

Prepared by:
Massachusetts Department of Public Health
Center of Environmental Health
Emergency Response/Indoor Air Quality Program
January 2006

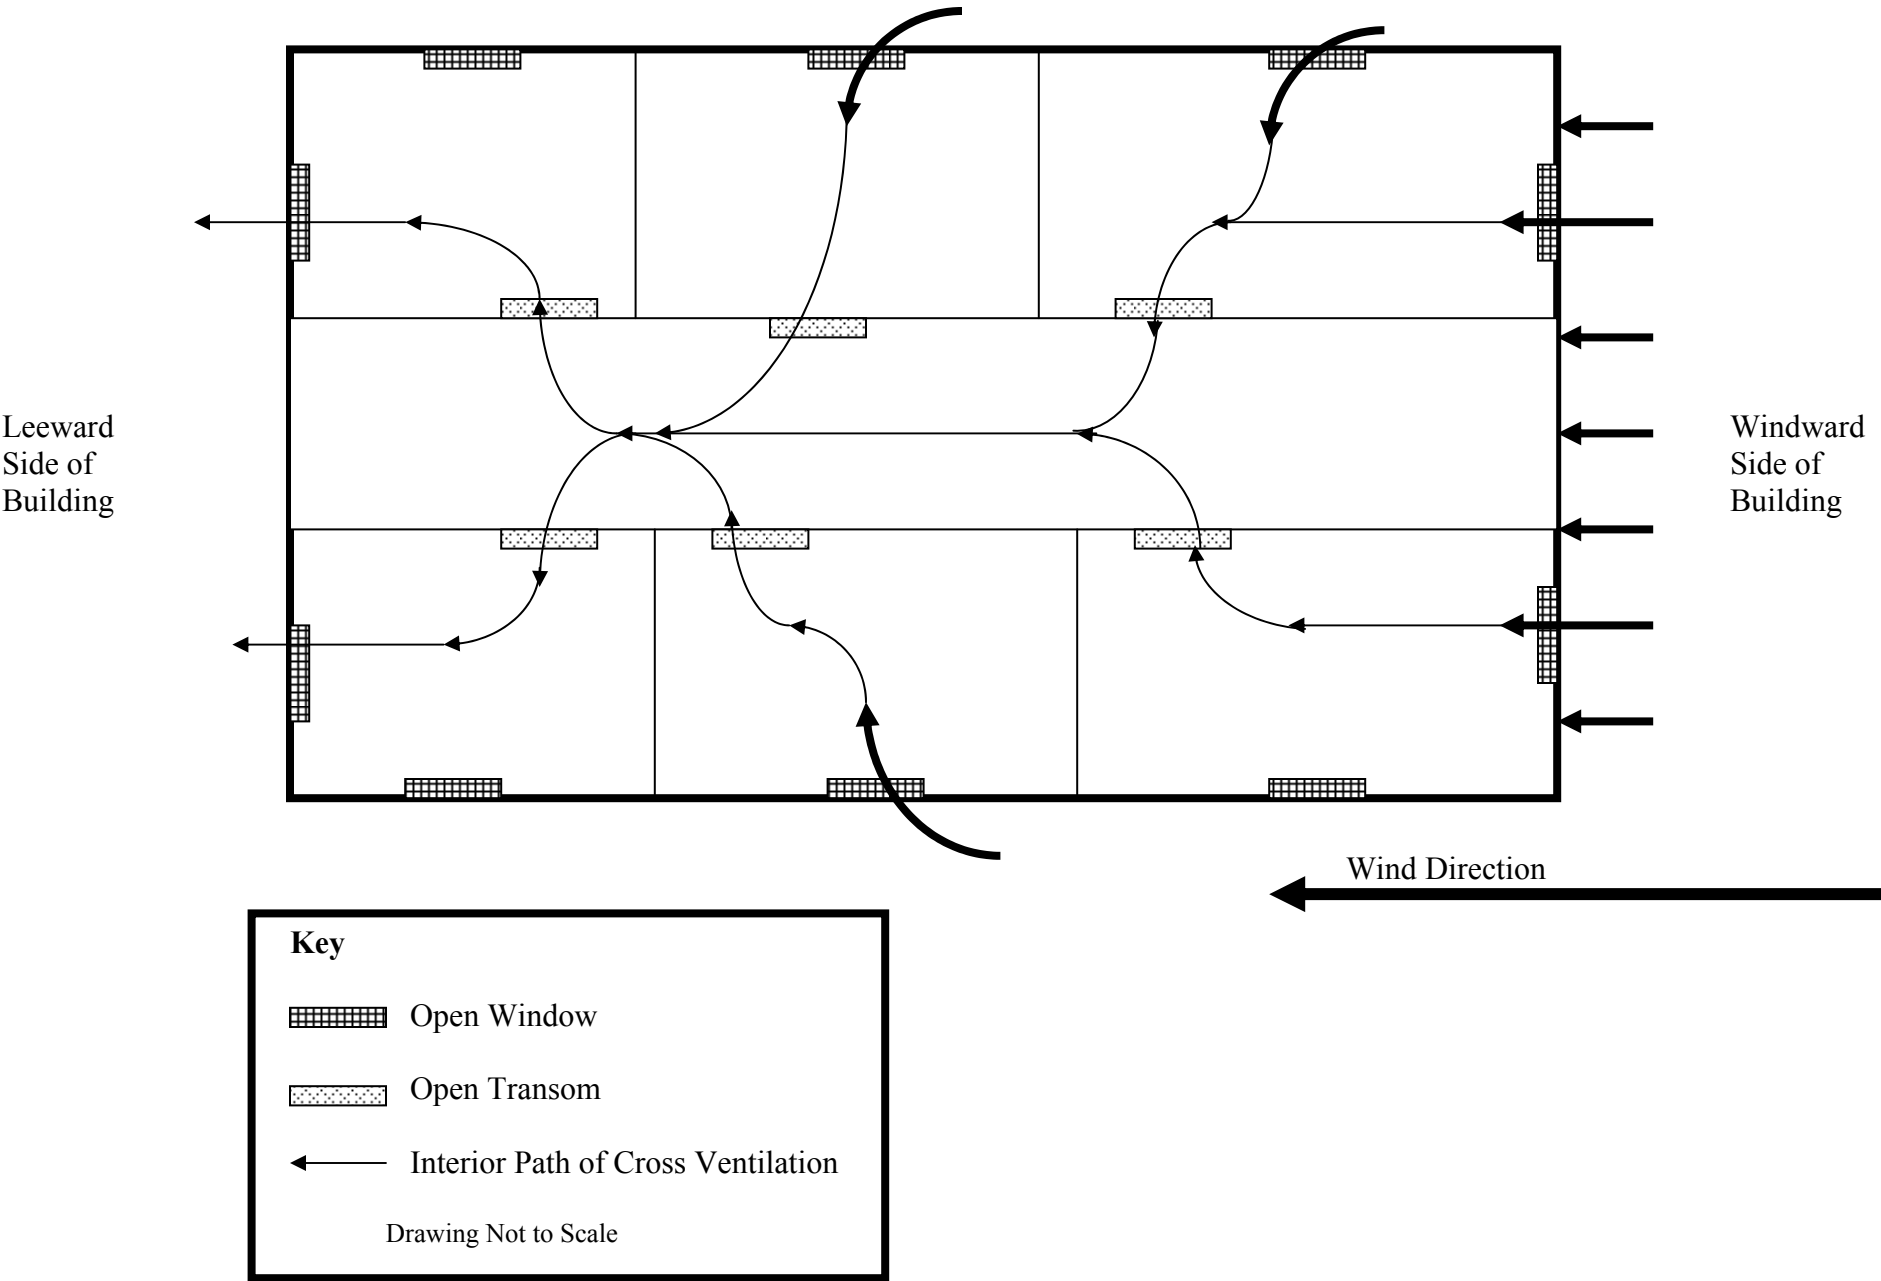
Figure 2

During summer months, ventilation was supplemented by the use of openable windows. The building was configured in a manner to use cross-ventilation to provide comfort for building occupants. The BTOB is equipped with windows on opposing exterior walls. This design allows for air to enter an open window, pass through a room, pass through the open door, enter the hallway, pass through the opposing room’s open door, into the opposing room and exit the building on the leeward side (opposite the windward side) (Figure 2). With all windows and hallway doors open, airflow can be maintained in a building regardless of the direction of the wind. The system fails if the windows or doors are closed (Figure 3). In addition, open windows may also allow for rainwater to penetrate through windows. Pests such as bats and insects also have access to the interior if windows are left open overnight.

Cross Ventilation in a Building Using Open Windows and Transoms

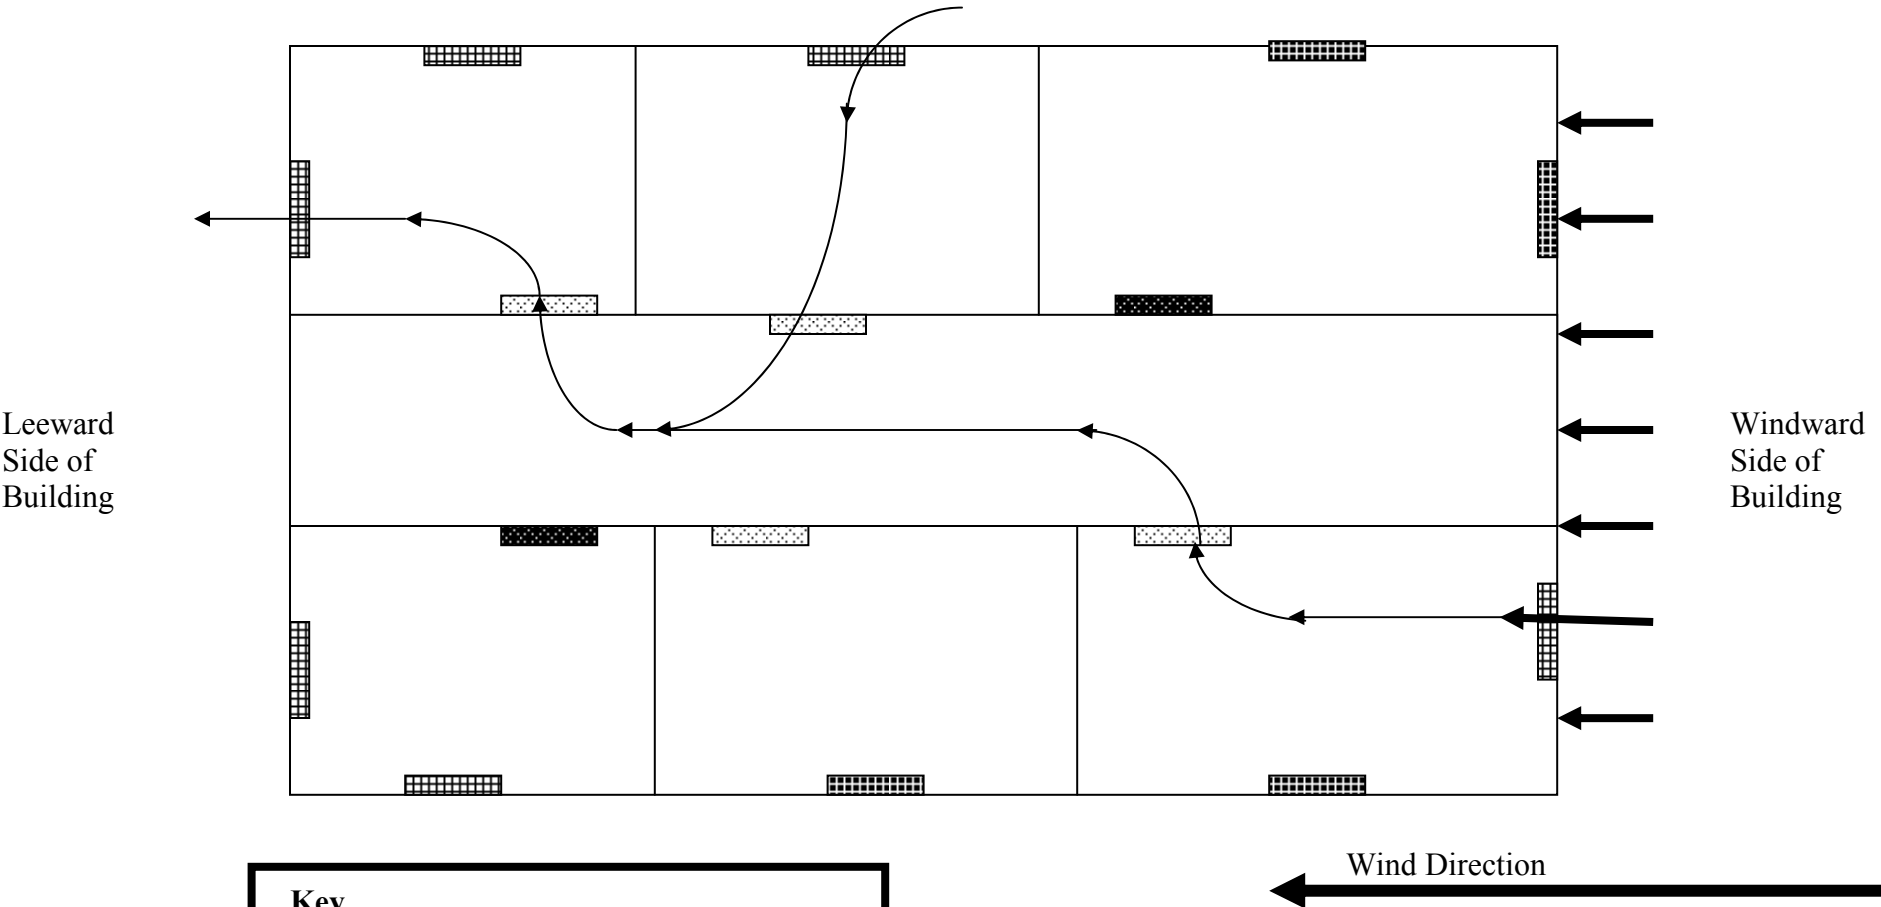
Figure 3

Inhibition of Cross Ventilation in a Building with Several Windows and Transoms Closed
